**Flood Control Project Maintenance  
Levee Inspections****LMA District Cover Sheet  
Spring 2015 Levee Inspection Results****American River Flood Control District**

**Spring 2015 Levee Inspection Results**

**American River Flood Control District**

Waterway			Bank	Unit Miles
Unit No. 01 Arcade Creek			Left	2.08
	Spring (March - May)	Summer (June - August)	(September - November) Fall	Winter (December - February)
Unit Maintenance Rating (Fall Only)				
Date of Inspection	04/30/2015 - 04/30/2015			
DWR Inspector	Maksim Khashchuk			
Accompanied By	Richard Marck ARFCD

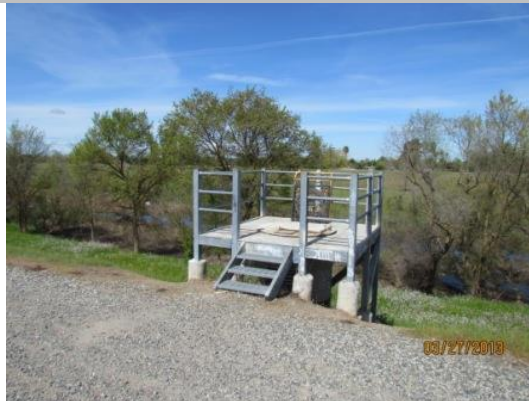
Photo 1 of 1 : SP\_2015\_NA0001\_51\_60\_20150317\_00034.jpg

LM Start	0.40	Rating **	A/W	Issue No.	60
LM End	0.40	Issue Type +	Ma	Location *	WS
Category	Earthen Levee			GPS Latitude/Longitude	
				Start	End
Item	Encroachments			38.622579 °	38.622579 °
				-121.461567 °	-121.461567 °
DWR ID	DWR_NA0001_01_s_2012_60				
Action/Comments					
Pipe

View of the pipe at the waterside levee hinge.

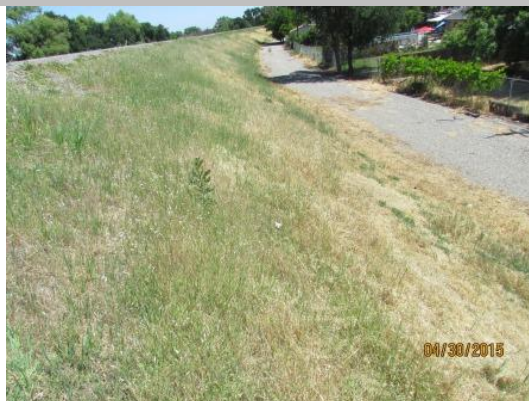
Photo 2 of 2 : SP\_2015\_NA0001\_51\_164\_20150504\_00053.jpg

LM Start	<b>0.48</b>	Rating **	A/W	Issue No.	<b>164 (cont)</b>
LM End	<b>0.48</b>	Issue Type +	Ma	Location *	LS

Another view of the depression on the landside levee slope.

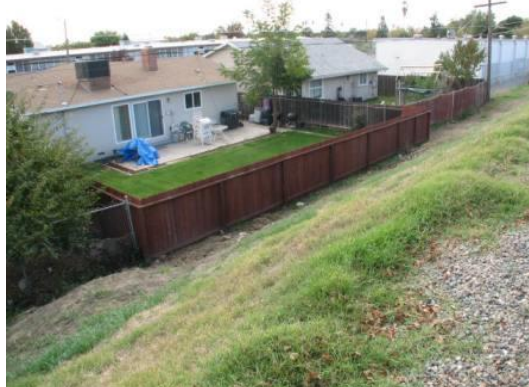
Photo 1 of 1 : SP\_2015\_NA0001\_51\_182\_20150317\_00044.jpg

LM Start	0.95	Rating **	U	Issue No.	182
LM End	0.95	Issue Type +	En	Location *	LS
Category	Earthen Levee			GPS Latitude/Longitude	
				Start	End
Item	Encroachments			38.625072 °	38.625072 °
				-121.452225 °	-121.452225 °
DWR ID	DWR_NA0001_01_s _ 2012_182				
Action/Comments					
Fence					
Inspector Comments: Dog-eared wooden fence built within 10' of the toe.

11/17/2011 Wooden privacy fence built at the levee toe.

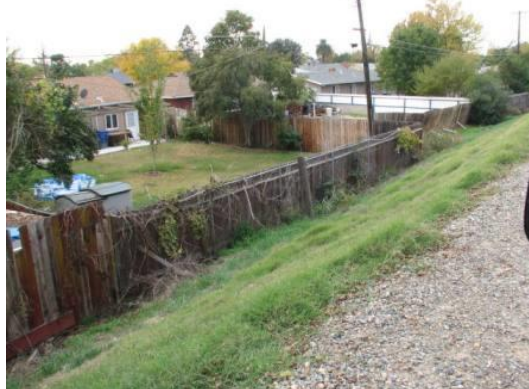
Photo 1 of 1 : SP\_2015\_NA0001\_51\_23\_20150317\_00020.jpg

LM Start	1.15	Rating **	U	Issue No.	23
LM End	1.15	Issue Type +	En	Location *	LS
Category	Earthen Levee			GPS Latitude/Longitude	
				Start	End
Item	Encroachments			38.624832 °	38.624832 °
				-121.448607 °	-121.448607 °
DWR ID	DWR_NA0001_01_s _ 2012_23				
Action/Comments					
Fence					
Inspector Comments: Dog-eared wooden fence and chain link fence is built against the levee slope.

11/17/2011 Fence built on the levee slope.

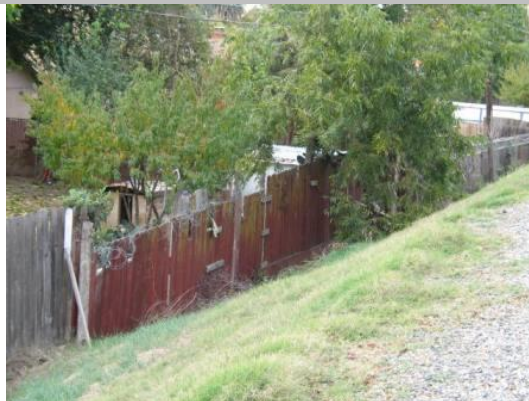
Photo 1 of 1 : SP\_2015\_NA0001\_51\_22\_20150317\_00019.jpg

LM Start	1.16	Rating **	U	Issue No.	22
LM End	1.16	Issue Type +	En	Location *	LS
Category	Earthen Levee			GPS Latitude/Longitude	
				Start	End
Item	Encroachments			38.624850 °	38.624850 °
				-121.448428 °	-121.448428 °
DWR ID	DWR_NA0001_01_s _ 2012_22				
Action/Comments					
Fence					
Inspector Comments: Dog-eared wooden fence is built against the levee slope.

11/17/2011 Wooden privacy fence built at the levee toe.

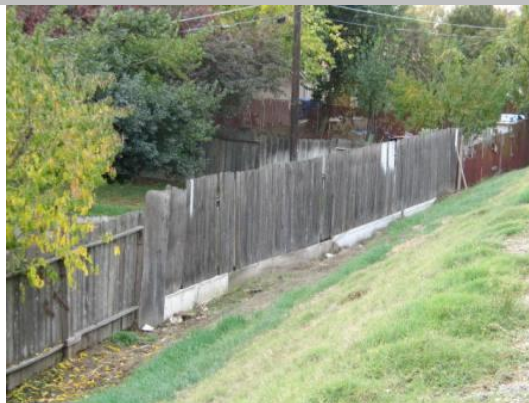
Photo 1 of 1 : SP\_2015\_NA0001\_51\_21\_20150317\_00018.jpg

LM Start	1.17	Rating **	U	Issue No.	21
LM End	1.17	Issue Type +	En	Location *	LS
Category	Earthen Levee			GPS Latitude/Longitude	
				Start	End
Item	Encroachments			38.624877 °	38.624877 °
				-121.448248 °	-121.448248 °
DWR ID	DWR_NA0001_01_s_2012_21				
Action/Comments					
Fence					
Inspector Comments: Dog-eared wooden fence is built against the levee slope.

11/17/2011 Wooden privacy fence built at the levee toe.

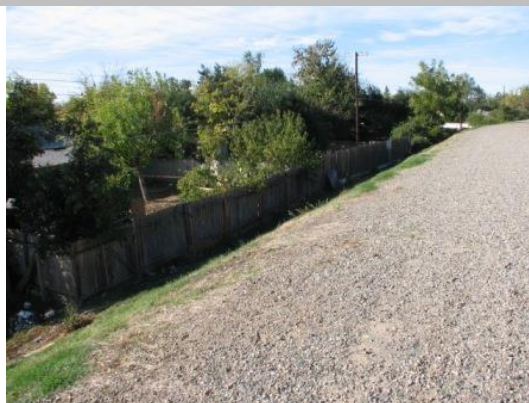
Photo 1 of 1 : SP\_2015\_NA0001\_51\_20\_20150317\_00017.jpg

LM Start	1.18	Rating **	U	Issue No.	20
LM End	1.18	Issue Type +	En	Location *	LS
Category	Earthen Levee			GPS Latitude/Longitude	
				Start	End
Item	Encroachments			38.624900 °	38.624900 °
				-121.448037 °	-121.448037 °
DWR ID	DWR_NA0001_01_s_2012_20				
Action/Comments					
Fence					
Inspector Comments: Dog-eared wooden fence is built against the levee slope.

Photo of solid fences built against the levee slope.

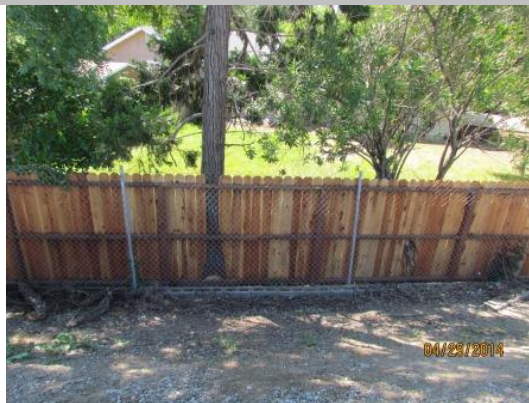
Photo 1 of 1 : SP\_2015\_NA0001\_51\_50\_20150317\_00031.jpg

LM Start	1.35	Rating **	U	Issue No.	50
LM End	1.35	Issue Type +	En	Location *	LS
Category	Earthen Levee			GPS Latitude/Longitude	
				Start	End
Item	Encroachments			38.625982 °	38.625982 °
				-121.445231 °	-121.445231 °
DWR ID	DWR_NA0001_01_s_2014_50				
Action/Comments					
Fence

View of the fence at the landside levee toe obstructing visibility and access.

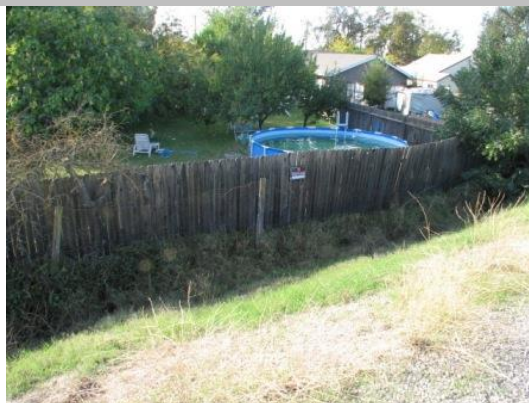
Photo 1 of 1 : SP\_2015\_NA0001\_51\_15\_20150317\_00013.jpg

LM Start	1.37	Rating **	U	Issue No.	15
LM End	1.37	Issue Type +	En	Location *	LS
Category	Earthen Levee			GPS Latitude/Longitude	
				Start	End
Item	Encroachments			38.626048 °	38.626048 °
				-121.444785 °	-121.444785 °
DWR ID	DWR_NA0001_01_s _ 2012_15				
Action/Comments					
Fence					
Inspector Comments: Wooden privacy fence with vine on levee slope.

Fall 2009 photo: Wooden and wire fence are within 10-ft of levee toe.

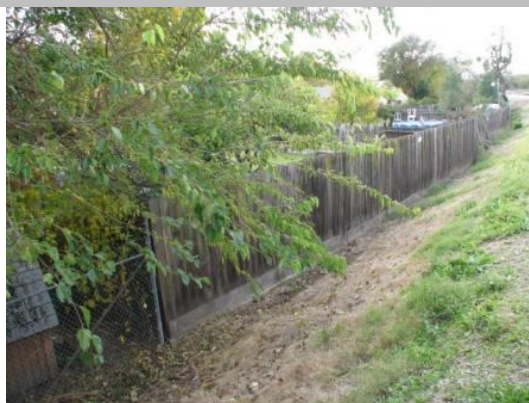
Photo 1 of 1 : SP\_2015\_NA0001\_51\_14\_20150317\_00012.jpg

LM Start	1.38	Rating **	U	Issue No.	14
LM End	1.38	Issue Type +	En	Location *	LS
Category	Earthen Levee			GPS Latitude/Longitude	
				Start	End
Item	Encroachments			38.626085 °	38.626085 °
				-121.444580 °	-121.444580 °
DWR ID	DWR_NA0001_01_s _ 2012_14				
Action/Comments					
Fence					
Inspector Comments: Wooden privacy fence

11/17/2011 Wooden privacy fence built at the levee toe.

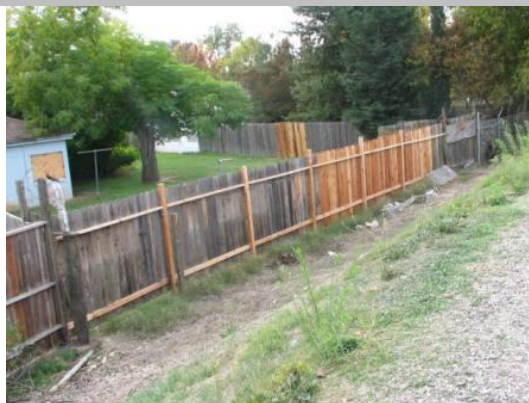
Photo 1 of 1 : SP\_2015\_NA0001\_51\_13\_20150317\_00011.jpg

LM Start	1.40	Rating **	U	Issue No.	13
LM End	1.40	Issue Type +	En	Location *	LS
Category	Earthen Levee			GPS Latitude/Longitude	
				Start	End
Item	Encroachments			38.626155 °	38.626155 °
				-121.444250 °	-121.444250 °
DWR ID	DWR_NA0001_01_s _ 2012_13				
Action/Comments					
Fence Inspector Comments: Wooden fence with barbed wire is built within 10-ft of levee toe. 04/13/2011 Fence has blown over and now partially rests on the levee. Fall insp 2011 fence has been rebuilt in same location, within 10' of levee toe.

11/17/2011 New wooden privacy fence built within 15' of the levee toe.

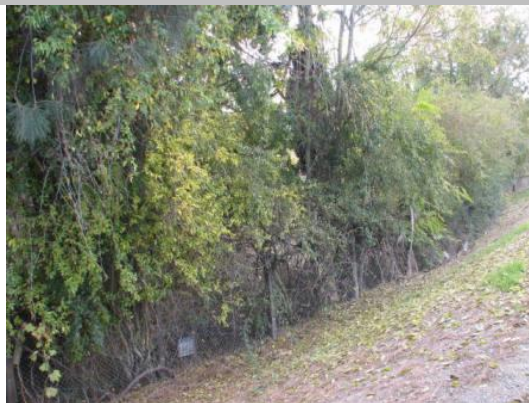
Photo 1 of 1 : SP\_2015\_NA0001\_51\_177\_20150317\_00042.jpg

LM Start	1.43	Rating **	U	Issue No.	177
LM End	1.43	Issue Type +	En	Location *	LS
Category	Earthen Levee			GPS Latitude/Longitude	
				Start	End
Item	Vegetation			38.626429 °	38.626429 °
				-121.443835 °	-121.443835 °
DWR ID	DWR_NA0001_01_s _ 2012_177				
Action/Comments					
Landscaping					
Inspector Comments: Thick vegetation at the toe.

11/17/2011 Thick vegetation at the levee toe.

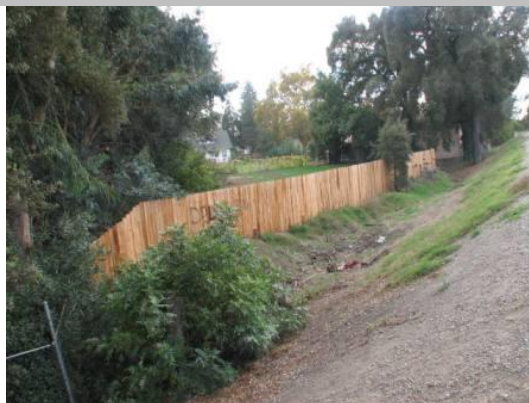
Photo 1 of 1 : SP\_2015\_NA0001\_51\_176\_20150317\_00041.jpg

LM Start	1.47	Rating **	U	Issue No.	176
LM End	1.47	Issue Type +	En	Location *	LS
Category	Earthen Levee			GPS Latitude/Longitude	
				Start	End
Item	Encroachments			38.626881 °	38.626881 °
				-121.443253 °	-121.443253 °
DWR ID	DWR_NA0001_01_s _ 2012_176				
Action/Comments					
Fence					
Inspector Comments: Wooden privacy fence within 10' of the levee toe.

11/17/2011 Wooden privacy fence built within 15' of the levee toe.

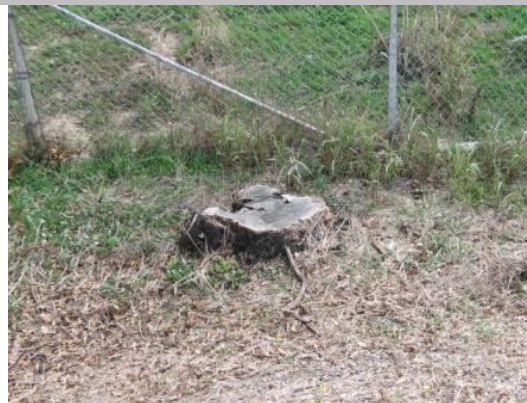
Photo 1 of 1 : SP\_2015\_NA0001\_51\_173\_20150317\_00040.jpg

LM Start	1.65	Rating **	N	Issue No.	173
LM End	1.65	Issue Type +	Ma	Location *	LS
Category	Earthen Levee			GPS Latitude/Longitude	
				Start	End
Item	Trim / Thin Trees			38.627297 °	38.627297 °
				-121.440188 °	-121.440188 °
DWR ID	DWR_NA0001_01_s_2012_173				
Action/Comments					
Tree stumps.					
Inspector Comments: Large stump at levee toe.

11/17/2011 Stump at levee toe.

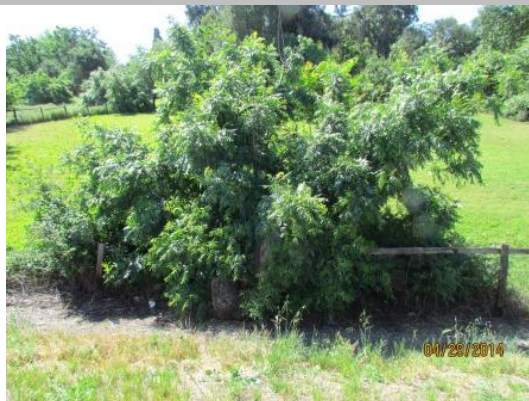
Photo 1 of 1 : SP\_2015\_NA0001\_51\_48\_20150317\_00030.jpg

LM Start	1.69	Rating **	A/W	Issue No.	48
LM End	1.69	Issue Type +	Ma	Location *	LS
Category	Earthen Levee			GPS Latitude/Longitude	
				Start	End
Item	Vegetation			38.627594 °	38.627594 °
				-121.439540 °	-121.439540 °
DWR ID	DWR_NA0001_01_s_2014_48				
Action/Comments					
Trees / Woody Vegetation					
Inspector Comments: Tree obstructing visibility and access.

View of the overgrown tree at the landside levee toe.

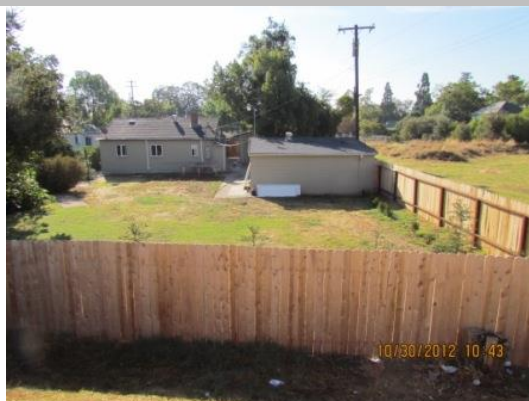
Photo 1 of 1 : SP\_2015\_NA0001\_51\_10\_20150317\_00009.jpg

LM Start	1.80	Rating **	U	Issue No.	10
LM End	1.80	Issue Type +	En	Location *	LS
Category	Earthen Levee			GPS Latitude/Longitude	
				Start	End
Item	Encroachments			38.627946 °	38.627946 °
				-121.437624 °	-121.437624 °
DWR ID	DWR_NA0001_01_f_2012_10				
Action/Comments					
Fence Inspector Comments: New fence constructed with 7 redwood planted at levee toe.

View of new fence constructed at levee toe and 7 redwood trees planted behind fence within easement.

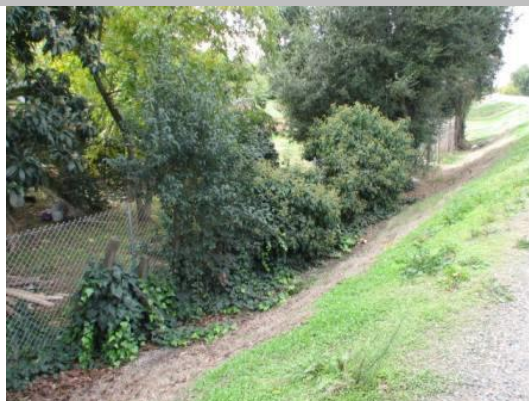
Photo 1 of 1 : SP\_2015\_NA0001\_51\_170\_20150317\_00039.jpg

LM Start	1.81	Rating **	U	Issue No.	170	
LM End	1.81	Issue Type +	En	Location *	LS	
Category	Earthen Levee			GPS Latitude/Longitude		
				Start		End
Item	Vegetation			38.627934 °		38.627934 °
				-121.437423 °		-121.437423 °
DWR ID	DWR_NA0001_01_s_2012_170					
Action/Comments						
Landscaping						
Inspector Comments: Growth on old wooden fence, which has since been replaced by a chainlink fence is obstructive.

11/17/2011 Growth on existing wooden fence is obstructive.

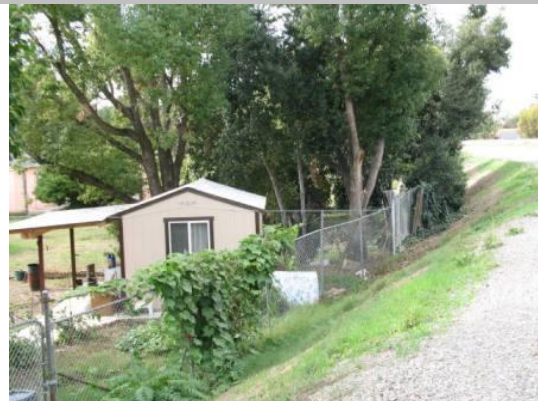
Photo 1 of 1 : SP\_2015\_NA0001\_51\_169\_20150317\_00038.jpg

LM Start	1.82	Rating **	U	Issue No.	169
LM End	1.82	Issue Type +	En	Location *	LS
Category	Earthen Levee			GPS Latitude/Longitude	
				Start	End
Item	Encroachments			38.627914 °	38.627914 °
				-121.437263 °	-121.437263 °
DWR ID	DWR_NA0001_01_s _ 2012_169				
Action/Comments					
Building					
Inspector Comments: Shed on concrete pad within 10' of the levee toe.

11/17/2011 Wooden shed on concrete pad built within 15' of levee toe.

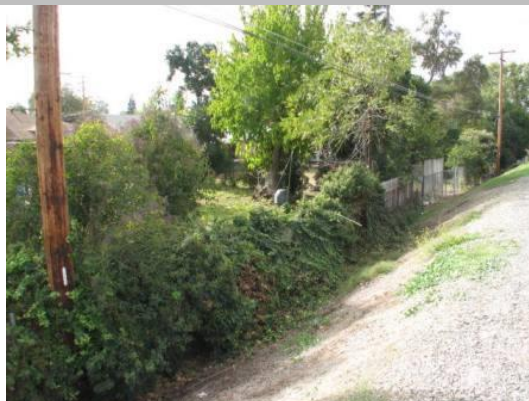
Photo 1 of 1 : SP\_2015\_NA0001\_51\_8\_20150317\_00007.jpg

LM Start	1.85	Rating **	M	Issue No.	8
LM End	1.85	Issue Type +	En	Location *	LS
Category	Earthen Levee			GPS Latitude/Longitude	
				Start	End
Item	Vegetation			38.627889 °	38.627889 °
				-121.436638 °	-121.436638 °
DWR ID	DWR_NA0001_01_s _ 2012_8				
Action/Comments					
Landscaping					
Inspector Comments: Ivy, trees and other landscaping growing on a wooden privacy fence are obstructing visibility.

11/17/2011 Landscaping vegetation growth on the fence is obstructive.

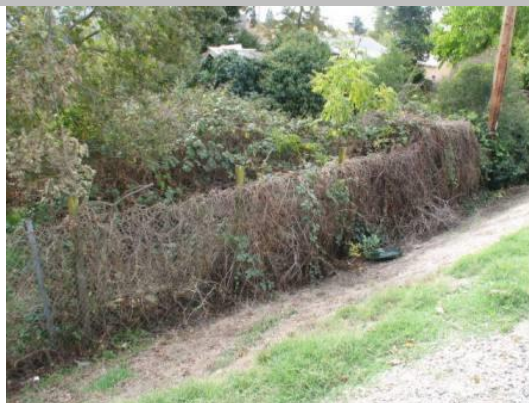
Photo 1 of 1 : SP\_2015\_NA0001\_51\_7\_20150317\_00006.jpg

LM Start	1.86	Rating **	U	Issue No.	7
LM End	1.86	Issue Type +	En	Location *	LS
Category	Earthen Levee			GPS Latitude/Longitude	
				Start	End
Item	Vegetation			38.627889 °	38.627889 °
				-121.436454 °	-121.436454 °
DWR ID	DWR_NA0001_01_s _ 2012_7				
Action/Comments					
Landscaping Inspector Comments: Metal sided shelter, blackberries and cherry trees are obstructive.

11/17/2011 Blackberries growing on fence are obstructive.

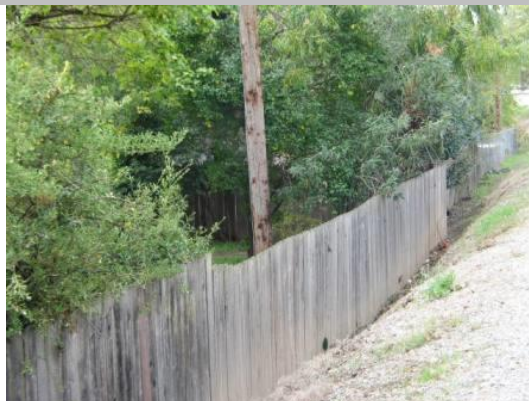
Photo 1 of 1 : SP\_2015\_NA0001\_51\_5\_20150317\_00004.jpg

LM Start	1.91	Rating **	U	Issue No.	5
LM End	1.91	Issue Type +	En	Location *	LS
Category	Earthen Levee			GPS Latitude/Longitude	
				Start	End
Item	Encroachments			38.627680 °	38.627680 °
				-121.435555 °	-121.435555 °
DWR ID	DWR_NA0001_01_s _ 2012_5				
Action/Comments					
Fence					
Inspector Comments: Dog-eared wooden fence is built against the levee slope.

11/17/2011 Wooden privacy fence built at the levee toe.

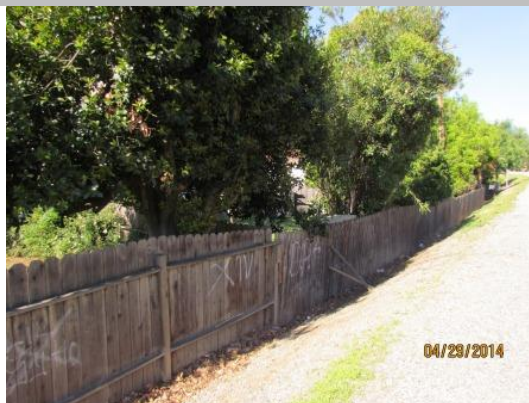
Photo 1 of 1 : SP\_2015\_NA0001\_51\_4\_20150317\_00003.jpg

LM Start	1.93	Rating **	U	Issue No.	4
LM End	1.93	Issue Type +	En	Location *	LS
Category	Earthen Levee			GPS Latitude/Longitude	
				Start	End
Item	Encroachments			38.627683 °	38.627683 °
				-121.435298 °	-121.435298 °
DWR ID	DWR_NA0001_01_s _ 2012_4				
Action/Comments					
Fence Inspector Comments: Wooden fence and landscaping completely block visibility.

View of the wooden fence at the landside levee toe.

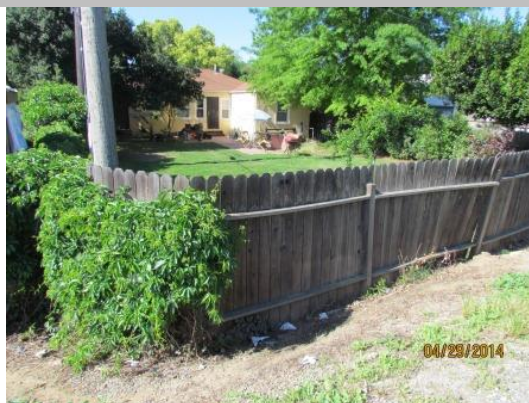
Photo 1 of 1 : SP\_2015\_NA0001\_51\_3\_20150317\_00002.jpg

LM Start	1.93	Rating **	U	Issue No.	3
LM End	1.93	Issue Type +	En	Location *	LS
Category	Earthen Levee			GPS Latitude/Longitude	
				Start	End
Item	Encroachments			38.627658 °	38.627658 °
				-121.435192 °	-121.435192 °
DWR ID	DWR_NA0001_01_s _ 2012_3				
Action/Comments					
Fence					
Inspector Comments: Dog-eared wooden fence is built against the levee slope.

View of the fence at the landside levee toe.

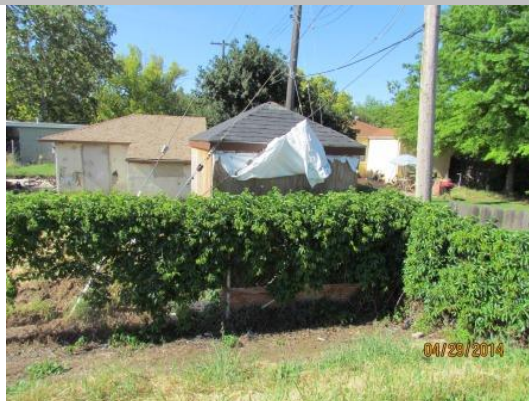
Photo 1 of 1 : SP\_2015\_NA0001\_51\_30\_20150317\_00024.jpg

LM Start	1.93	Rating **	U	Issue No.	30
LM End	1.93	Issue Type +	En	Location *	LS
Category	Earthen Levee			GPS Latitude/Longitude	
				Start	End
Item	Encroachments			38.627646 °	38.627646 °
				-121.435151 °	-121.435151 °
DWR ID	DWR_NA0001_01_s_2012_30				
Action/Comments					
Building					
Inspector Comments: Concrete pad and wooden frame structure is being built within 15-ft of levee toe.

Building on concrete pad within 15 feet of the landside levee toe.

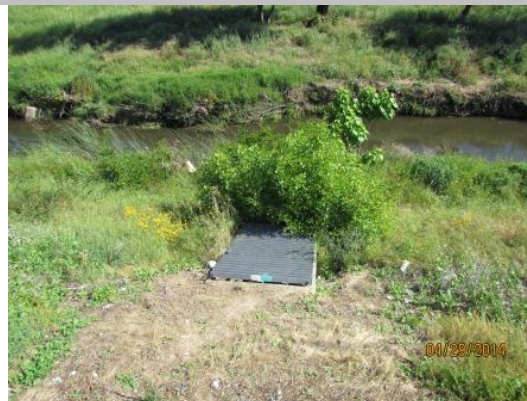
Photo 1 of 1 : SP\_2015\_NA0001\_51\_168\_20150317\_00037.jpg

LM Start	1.95	Rating **	A/W	Issue No.	168
LM End	1.95	Issue Type +	En	Location *	WS
Category	Earthen Levee			GPS Latitude/Longitude	
				Start	End
Item	Encroachments			38.627565 °	38.627565 °
				-121.434818 °	-121.434818 °
DWR ID	DWR_NA0001_01_s _ 2012_168				
Action/Comments					
Pipe					
Inspector Comments: Flap gate is blocked by tulies growing in the outfall structure. Gate is blocked in the closed position.

View of the vegetation obstructing the outfall.

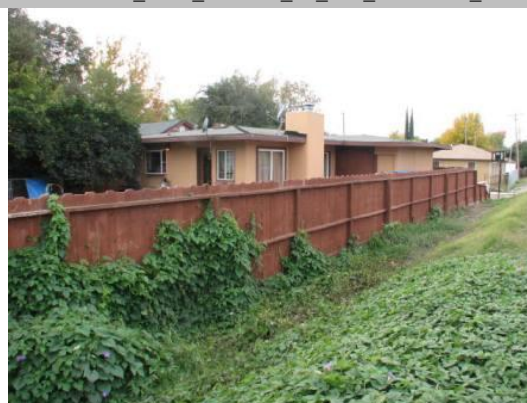
Photo 1 of 1 : SP\_2015\_NA0001\_51\_167\_20150317\_00036.jpg

LM Start	1.98	Rating **	U	Issue No.	167
LM End	1.98	Issue Type +	En	Location *	LS
Category	Earthen Levee			GPS Latitude/Longitude	
				Start	End
Item	Encroachments			38.627433 °	38.627433 °
				-121.434341 °	-121.434341 °
DWR ID	DWR_NA0001_01_s _ 2012_167				
Action/Comments					
Fence					
Inspector Comments: Wooden privacy fence within 10' of the levee toe.

11/17/2011 Wooden privacy fence built at the levee toe.

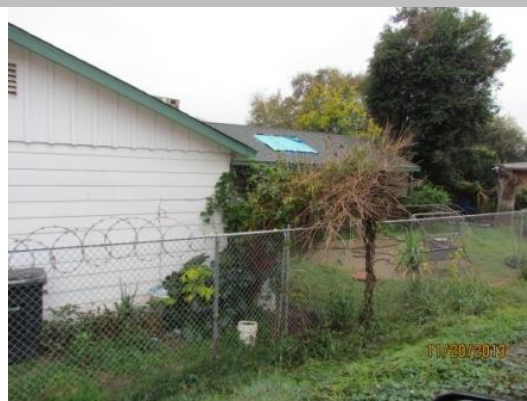
Photo 1 of 1 : SP\_2015\_NA0001\_51\_1\_20150317\_00001.jpg

LM Start	1.99	Rating **	M	Issue No.	1
LM End	1.99	Issue Type +	En	Location *	LS
Category	Earthen Levee			GPS Latitude/Longitude	
				Start	End
Item	Vegetation			38.627318 °	38.627318 °
				-121.434208 °	-121.434208 °
DWR ID	DWR_NA0001_01_s _ 2012_1				
Action/Comments					
Landscaping					
Inspector Comments: Vine growing on fence and slope blocks visibility.

View of the fence and landscaping at the landside levee toe.

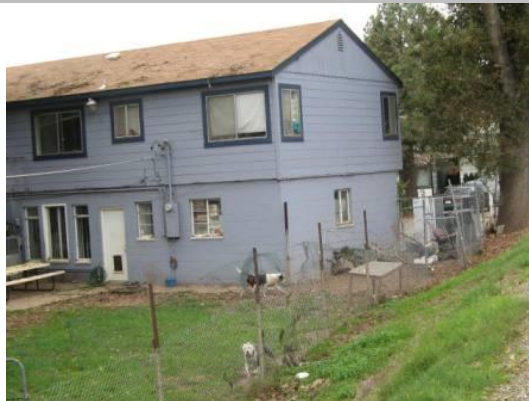
Photo 1 of 1 : SP\_2015\_NA0001\_51\_29\_20150317\_00023.jpg

LM Start	2.02	Rating **	U	Issue No.	29
LM End	2.02	Issue Type +	En	Location *	LS
Category	Earthen Levee			GPS Latitude/Longitude	
				Start	End
Item	Encroachments			38.627292 °	38.627292 °
				-121.433709 °	-121.433709 °
DWR ID	DWR_NA0001_01_s _ 2012_29				
Action/Comments					
Building					
Inspector Comments: Two-story home foundation is within 10-ft of levee toe. Chain link fence is built on levee toe.

11/17/2011 Building foundation is within 15' of the levee toe.

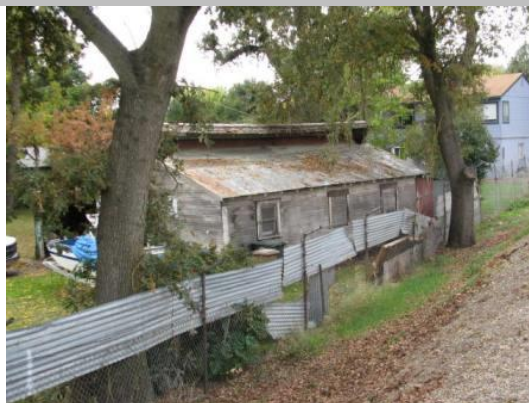
Photo 1 of 1 : SP\_2015\_NA0001\_51\_28\_20150317\_00022.jpg

LM Start	2.04	Rating **	U	Issue No.	28
LM End	2.04	Issue Type +	En	Location *	LS
Category	Earthen Levee			GPS Latitude/Longitude	
				Start	End
Item	Encroachments			38.627257 °	38.627257 °
				-121.433327 °	-121.433327 °
DWR ID	DWR_NA0001_01_s _ 2012_28				
Action/Comments					
Building Inspector Comments: Large wooden building behind corrugated metal covered fence is within 10-ft of levee toe.

11/17/2011 Wooden structure is within 15' of the levee toe.

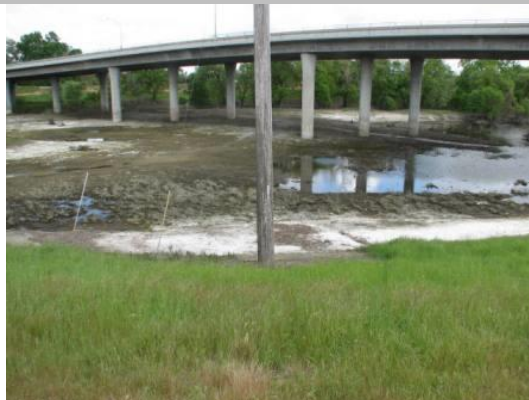
Photo 1 of 1 : SP\_2015\_NA0001\_52\_2\_20150317\_00001.jpg

LM Start	0.33	Rating **	M	Issue No.	2
LM End	0.33	Issue Type +	En	Location *	WS
Category	Earthen Levee			GPS Latitude/Longitude	
				Start	End
Item	Encroachments			38.605822 °	38.605822 °
				-121.468078 °	-121.468078 °
DWR ID	DWR_NA0001_02_s_2012_2				
Action/Comments					
Pole					
Inspector Comments: Power pole in levee

04/13/2011 Power pole is in the levee on the water side.

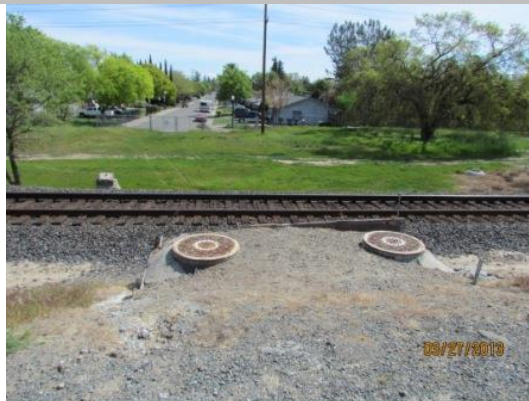
Photo 1 of 1 : SP\_2015\_NA0001\_52\_7\_20150317\_00003.jpg

Action/Comments					
Pipe Inspector Comments: Manhole access to pipes on hinge point.

View of the pipe access at the landside levee hinge.

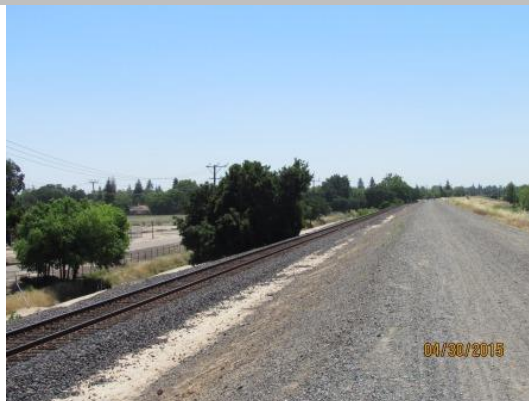
Photo 1 of 1 : SP\_2015\_NA0001\_52\_24\_20150504\_00013.jpg

LM Start	1.15	Rating **	A	Issue No.	24
LM End	1.15	Issue Type +	Ma	Location *	LS
Category	Earthen Levee			GPS Latitude/Longitude	
				Start	End
Item	Vegetation			38.617530 °	38.617530 °
				-121.467273 °	-121.467273 °
DWR ID	DWR_NA0001_02_s_2015_24				
Action/Comments					
Control annual grass and weeds on the levee slopes and easements.

View of the acceptable vegetation control on the landside levee slope.

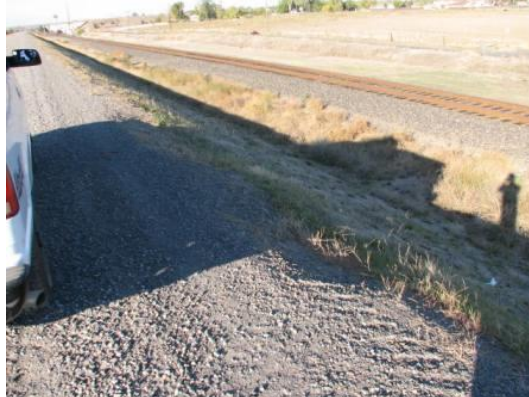
Photo 2 of 2 : SP\_2015\_NA0001\_52\_150\_20150317\_00007.jpg

LM Start	2.33	Rating **	A/W	Issue No.	150 (cont)	
LM End	2.33	Issue Type +	Ob	Location *	LS	
Category	Earthen Levee			GPS Latitude/Longitude		
				Start		End
Item	Erosion / Bank Caving			38.634446 °	38.634446 °	
				-121.470573 °	-121.470573 °	
DWR ID	DWR_NA0001_02_s_2012_150					
Action/Comments						
Note and monitor erosion site.						
Inspector Comments: Monitor erosion at this location. Also noted in USACE PI.

11/16/2011 Depressions present on levee slope.

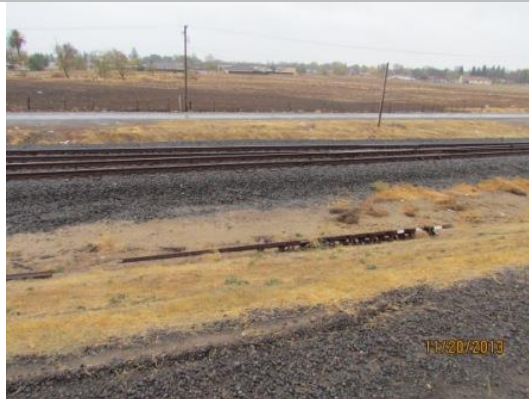
Photo 1 of 1 : SP\_2015\_NA0001\_52\_11\_20150317\_00005.jpg

LM Start	2.52	Rating **	M	Issue No.	11
LM End	2.52	Issue Type +	En	Location *	LS
Category	Earthen Levee			GPS Latitude/Longitude	
				Start	End
Item	Encroachments			38.637177 °	38.637177 °
				-121.471076 °	-121.471076 °
DWR ID	DWR_NA0001_02_f_2013_11				
Action/Comments					
Material					
Inspector Comments: Railroad rails on landside levee slope.

View of the rails at the landside levee toe.

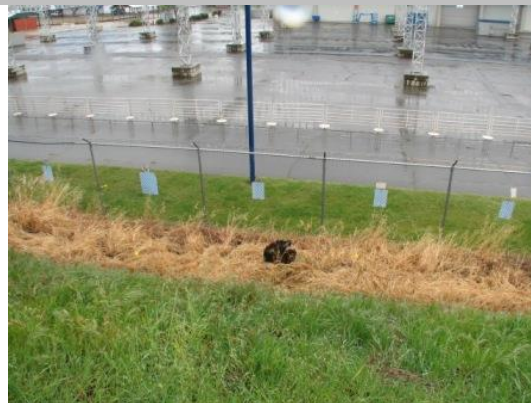
Photo 1 of 1 : SP\_2015\_NA0001\_490\_11\_20150317\_00003.jpg

LM Start	0.75	Rating **	N	Issue No.	11
LM End	0.75	Issue Type +	Ma	Location *	LS
Category	Earthen Levee			GPS Latitude/Longitude	
				Start	End
Item	Trim / Thin Trees			38.589359 °	38.589359 °
				-121.430990 °	-121.430990 °
DWR ID	DWR_NA0001_03_s_2012_11				
Action/Comments					
Tree stumps.					
Inspector Comments: Tree stump >2" Dia.

Tree stump on levee slope greater than 2" Dia.

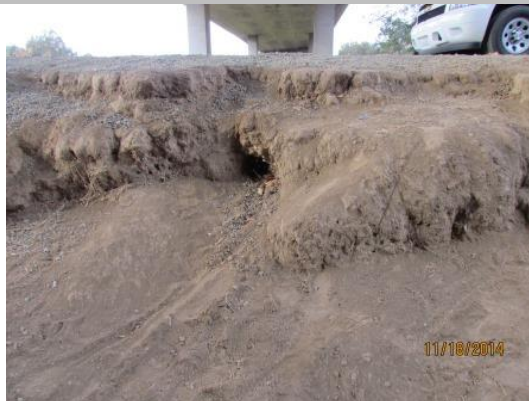
Photo 1 of 1 : SP\_2015\_NA0001\_490\_1\_20150317\_00001.jpg

LM Start	3.17	Rating **	A/W	Issue No.	1
LM End	3.17	Issue Type +	Ma	Location *	LS
Category	Earthen Levee			GPS Latitude/Longitude	
				Start	End
Item	Animal Control			38.599141 °	38.599141 °
				-121.470227 °	-121.470227 °
DWR ID	DWR_NA0001_03_f_2013_1				
Action/Comments					
No rodents visible, but rodent burrows visible; need to backfill and compact or grout burrows.

View of the rodent holes on the landside levee slope.

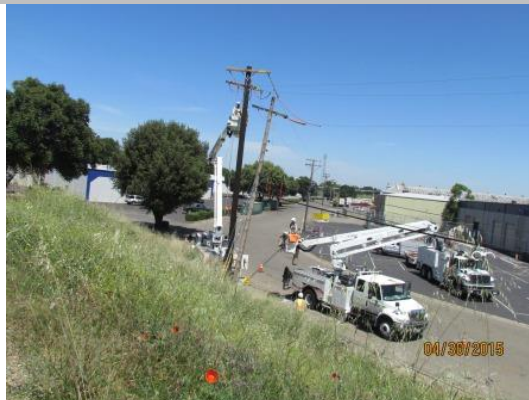
Photo 1 of 1 : SP\_2015\_NA0001\_490\_24\_20150504\_00011.jpg

LM Start	3.31	Rating **	M	Issue No.	24
LM End	3.31	Issue Type +	En	Location *	LS
Category	Earthen Levee			GPS Latitude/Longitude	
				Start	End
Item	Encroachments			38.600958 °	38.600958 °
				-121.471618 °	-121.471618 °
DWR ID	DWR_NA0001_03_s_2015_24				
Action/Comments					
Pole					
Inspector Comments: SMUD replacing old pole at the landside toe of the levee. May or may not be permitted.

View of a new pole installed at the landside levee toe.

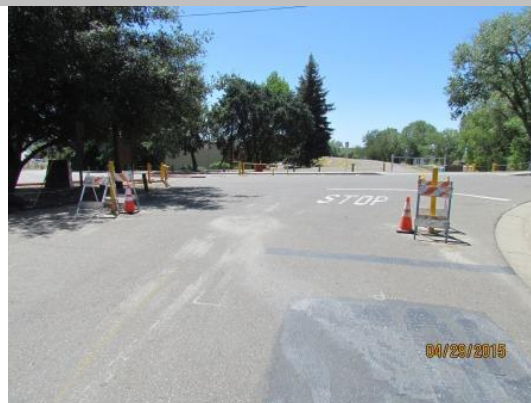
Photo 1 of 1 : SP\_2015\_NA0001\_55\_242\_20150504\_00215.jpg

LM Start	0.20	Rating **	M	Issue No.	242
LM End	0.20	Issue Type +	En	Location *	CR
Category	Earthen Levee			GPS Latitude/Longitude	
				Start	End
Item	Encroachments			38.598832 °	38.598832 °
				-121.504984 °	-121.504984 °
DWR ID	DWR_NA0001_04_s _ 2015_242				
Action/Comments					
Fence					
Inspector Comments: Unpermitted gate being installed by Sacramento County Parks.

View of the gate installation in progress on the levee crown.

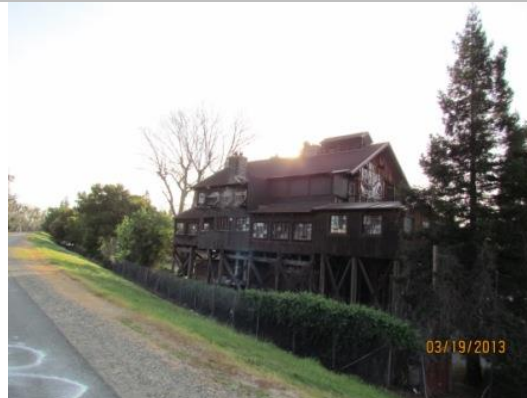
Photo 1 of 1 : SP\_2015\_NA0001\_55\_1\_20150317\_00001.jpg

LM Start	0.31	Rating **	M	Issue No.	1
LM End	0.45	Issue Type +	En	Location *	LS
Category	Earthen Levee			GPS Latitude/Longitude	
				Start	End
Item	Vegetation			38.599835 °	38.600769 °
				-121.503448 °	-121.501133 °
DWR ID	DWR_NA0001_04_s_2012_1				
Action/Comments					
Landscaping					
Inspector Comments: Vines and privacy fence within 10-ft of the landside toe or on the levee slope obstruct visibility and access.

View of the vines obstructing visibility.

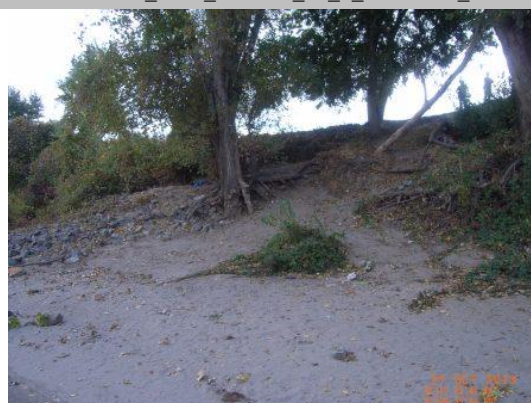
Photo 1 of 1 : SP\_2015\_NA0001\_55\_7\_20150317\_00007.jpg

LM Start	1.61	Rating **	M	Issue No.	7
LM End	1.65	Issue Type +	Ma	Location *	WS
Category	Supplemental			GPS Latitude/Longitude	
				Start	End
Item	USACE Erosion Survey			38.599095 °	38.598791 °
				-121.480337 °	-121.479799 °
DWR ID	DWR_NA0001_04_f _ 2014_7				
Action/Comments					
Inspector Comments: 2012 - Located just downstream of older repair. Failing rock at the upstream end. Erosion of the bank has exposed large tree roots. 2013: No observed changes. [2013 Site ID: LAR_1-8_L]

USACE 2013 Photo #1

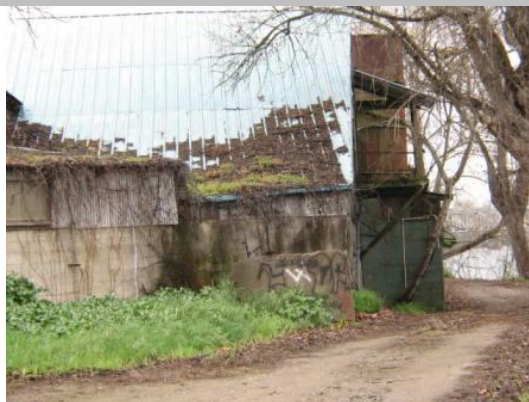
Photo 1 of 1 : SP\_2015\_NA0001\_55\_2\_20150317\_00002.jpg

LM Start	2.68	Rating **	U	Issue No.	2
LM End	2.68	Issue Type +	En	Location *	LS
Category	Earthen Levee			GPS Latitude/Longitude	
				Start	End
Item	Encroachments			38.588913 °	38.588913 °
				-121.467210 °	-121.467210 °
DWR ID	DWR_NA0001_04_s_2012_2				
Action/Comments					
Building					
Inspector Comments: Bell Marine

03/16/2012 Structure on Bell Marine property.

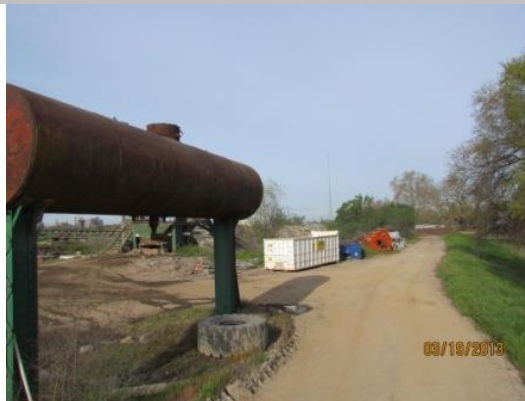
Photo 1 of 1 : SP\_2015\_NA0001\_55\_3\_20150317\_00003.jpg

LM Start	2.72	Rating **	M	Issue No.	3
LM End	2.86	Issue Type +	En	Location *	LS
Category	Earthen Levee			GPS Latitude/Longitude	
				Start	End
Item	Encroachments			38.587939 °	38.587299 °
				-121.466635 °	-121.464320 °
DWR ID	DWR_NA0001_04_s_2012_3				
Action/Comments					
Equipment					
Inspector Comments: Bell Marine, LMA sent a letter to property owner for the violation.

View of the debris obstructing visibility and access.

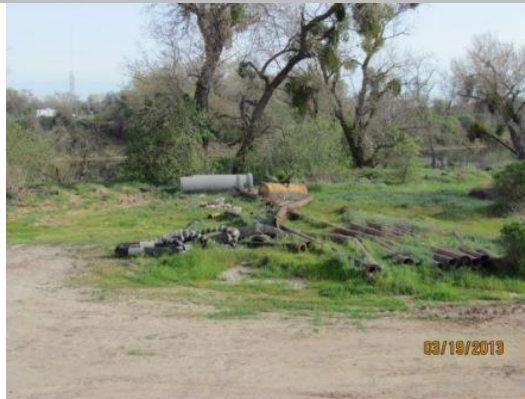
Photo 1 of 1 : SP\_2015\_NA0001\_55\_4\_20150317\_00004.jpg

LM Start	2.83	Rating **	M	Issue No.	4
LM End	2.83	Issue Type +	En	Location *	WS
Category	Earthen Levee			GPS Latitude/Longitude	
				Start	End
Item	Encroachments			38.587272 °	38.587272 °
				-121.464768 °	-121.464768 °
DWR ID	DWR_NA0001_04_s_2012_4				
Action/Comments					
Debris					
Inspector Comments: Bell Marine, LMA sent a letter to the property owner for this violation.

View of the debris stored in floodway.

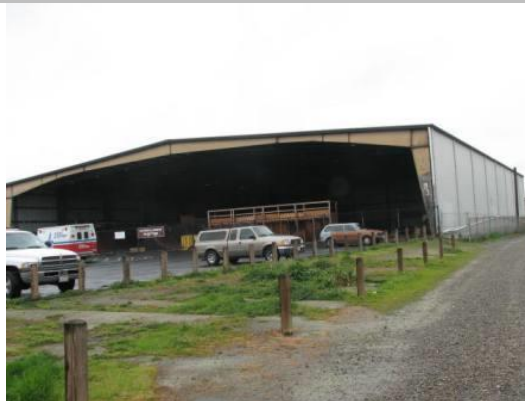
Photo 1 of 1 : SP\_2015\_NA0001\_55\_5\_20150317\_00005.jpg

LM Start	2.92	Rating **	U	Issue No.	5
LM End	2.96	Issue Type +	En	Location *	LS
Category	Earthen Levee			GPS Latitude/Longitude	
				Start	End
Item	Encroachments			38.587251 °	38.587318 °
				-121.463237 °	-121.462513 °
DWR ID	DWR_NA0001_04_s_2012_5				
Action/Comments					
Building					
Inspector Comments: City of Sacramento building. Building is now Sutter's Landing Skate Park.

03/16/2012 Sutter's Landing Skate Park.

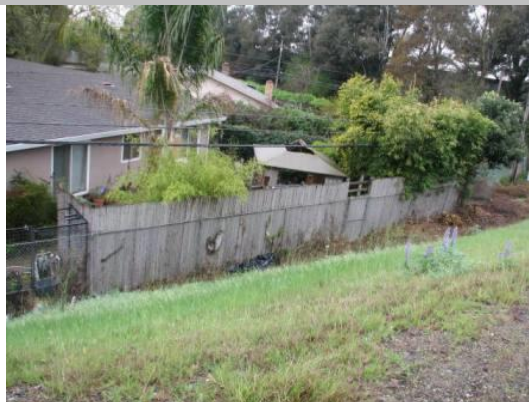
Photo 1 of 2 : SP\_2015\_NA0001\_55\_8\_20150317\_00008.jpg

LM Start	3.90	Rating **	U	Issue No.	8
LM End	3.90	Issue Type +	En	Location *	LS
Category	Earthen Levee			GPS Latitude/Longitude	
				Start	End
Item	Encroachments			38.586327 °	38.586327 °
				-121.447373 °	-121.447373 °
DWR ID	DWR_NA0001_04_s_2012_8				
Action/Comments					
Fence					
Inspector Comments: Bamboo privacy fence within 10-ft of the landside toe obstructs visibility.

03/16/2012 Wood privacy fence completely obstructs access and visibility.

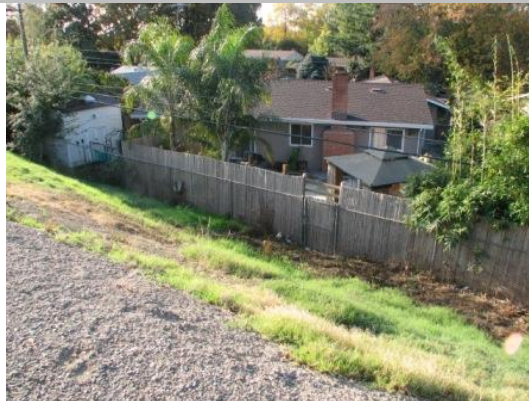
Photo 2 of 2 : SP\_2015\_NA0001\_55\_8\_20150317\_00009.jpg

LM Start	3.90	Rating **	U	Issue No.	8 (cont)	
LM End	3.90	Issue Type +	En	Location *	LS	
Category	Earthen Levee			GPS Latitude/Longitude		
				Start		End
Item	Encroachments			38.586327 °	38.586327 °	
				-121.447373 °	-121.447373 °	
DWR ID	DWR_NA0001_04_s_2012_8					
Action/Comments						
Fence						
Inspector Comments: Bamboo privacy fence within 10-ft of the landside toe obstructs visibility.

Fall 2009 photo: Fence and landscaping within 10-ft of levee toe obstructs access and visibility.

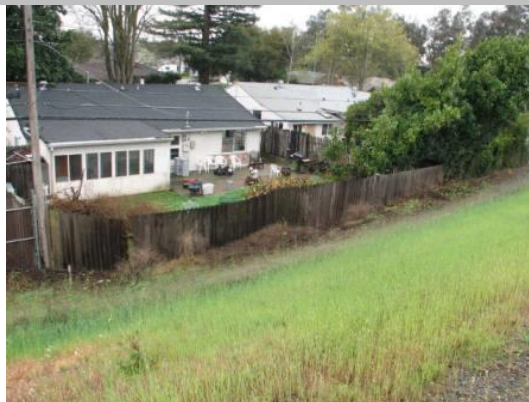
Photo 1 of 1 : SP\_2015\_NA0001\_55\_9\_20150317\_00010.jpg

LM Start	3.93	Rating **	U	Issue No.	9
LM End	3.93	Issue Type +	En	Location *	LS
Category	Earthen Levee			GPS Latitude/Longitude	
				Start	End
Item	Encroachments			38.586047 °	38.586047 °
				-121.446975 °	-121.446975 °
DWR ID	DWR_NA0001_04_s_2012_9				
Action/Comments					
Fence					
Inspector Comments: Wooden privacy fence on the levee slope obstructs access and visibility.

03/16/2012 Wood privacy fence completely obstructs access and visibility.

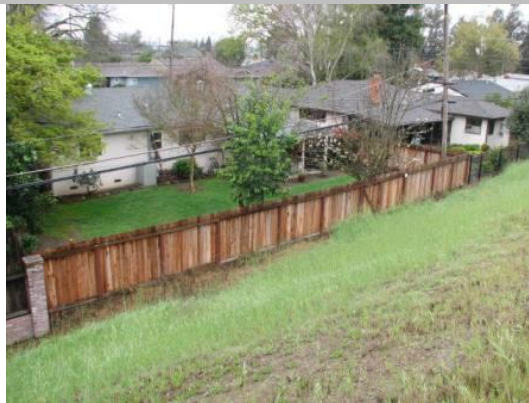
Photo 1 of 1 : SP\_2015\_NA0001\_55\_11\_20150317\_00011.jpg

LM Start	3.97	Rating **	U	Issue No.	11
LM End	3.97	Issue Type +	En	Location *	LS
Category	Earthen Levee			GPS Latitude/Longitude	
				Start	End
Item	Encroachments			38.585639 °	38.585639 °
				-121.446451 °	-121.446451 °
DWR ID	DWR_NA0001_04_s _ 2012_11				
Action/Comments					
Fence					
Inspector Comments: Privacy fence and landscaping within 10-ft of the levee toe obstruct access and visibility.

03/16/2012 Wood privacy fence completely obstructs access and visibility.

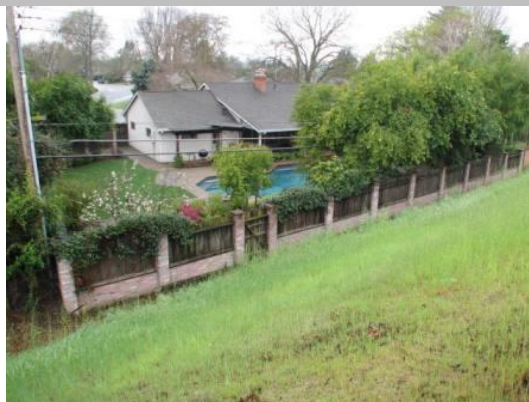
Photo 1 of 1 : SP\_2015\_NA0001\_55\_12\_20150317\_00012.jpg

LM Start	3.98	Rating **	U	Issue No.	12
LM End	3.98	Issue Type +	En	Location *	LS
Category	Earthen Levee			GPS Latitude/Longitude	
				Start	End
Item	Encroachments			38.585496 °	38.585496 °
				-121.446309 °	-121.446309 °
DWR ID	DWR_NA0001_04_s _ 2012_12				
Action/Comments					
Fence					
Inspector Comments: Privacy fence and landscaping within 10-ft of the levee toe obstruct access and visibility.

03/16/2012 Wood privacy fence completely obstructs access and visibility.

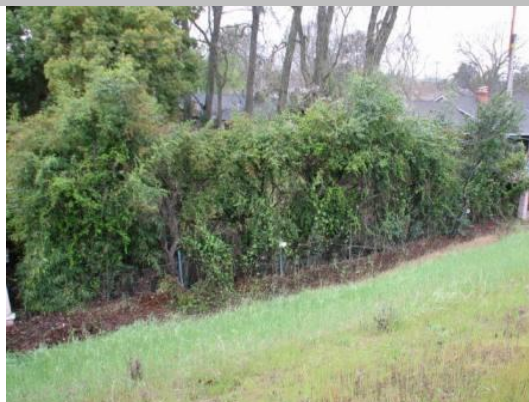
Photo 1 of 1 : SP\_2015\_NA0001\_55\_112\_20150317\_00095.jpg

LM Start	3.99	Rating **	U	Issue No.	112
LM End	3.99	Issue Type +	En	Location *	LS
Category	Earthen Levee			GPS Latitude/Longitude	
				Start	End
Item	Vegetation			38.585385 °	38.585385 °
				-121.446168 °	-121.446168 °
DWR ID	DWR_NA0001_04_s _ 2012_112				
Action/Comments					
Landscaping					
Inspector Comments: Landscaping completely blocks visibility.

03/16/2012 Landscape obstructs visibility and access.

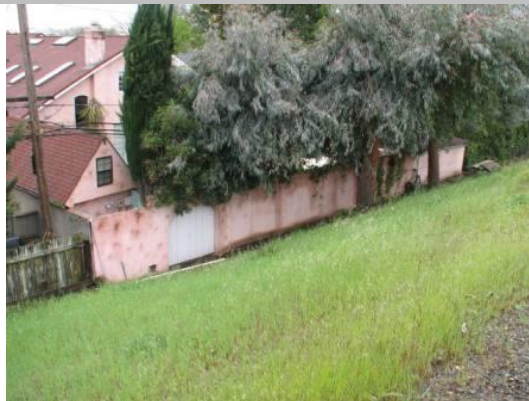
Photo 1 of 1 : SP\_2015\_NA0001\_55\_13\_20150317\_00013.jpg

LM Start	4.00	Rating **	U	Issue No.	13
LM End	4.00	Issue Type +	En	Location *	LS
Category	Earthen Levee			GPS Latitude/Longitude	
				Start	End
Item	Encroachments			38.585325 °	38.585325 °
				-121.446059 °	-121.446059 °
DWR ID	DWR_NA0001_04_s_2012_13				
Action/Comments					
Fence Inspector Comments: Pink cement block fence obstructs access and visibility.

03/16/2012 Concrete wall obstructs access and visibility.

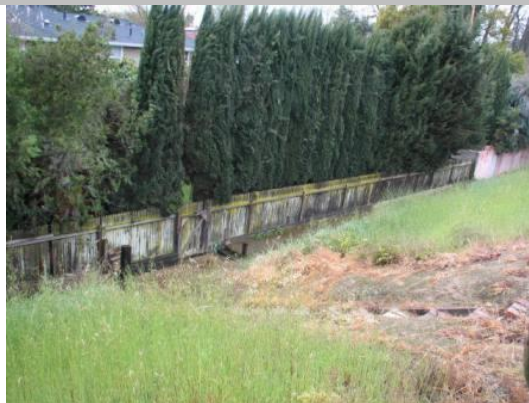
Photo 1 of 1 : SP\_2015\_NA0001\_55\_14\_20150317\_00014.jpg

LM Start	4.02	Rating **	U	Issue No.	14
LM End	4.02	Issue Type +	En	Location *	LS
Category	Earthen Levee			GPS Latitude/Longitude	
				Start	End
Item	Encroachments			38.585175 °	38.585175 °
				-121.445883 °	-121.445883 °
DWR ID	DWR_NA0001_04_s_2012_14				
Action/Comments					
Fence					
Inspector Comments: Privacy fence and helix pencil shrubs planted within 10-ft of the levee toe obstruct access and visibility.

03/16/2012 Wood privacy fence completely obstructs access and visibility.

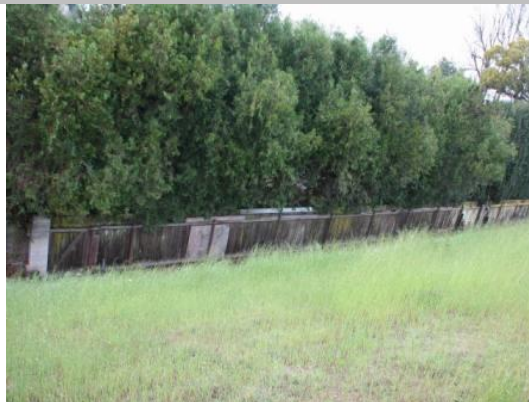
Photo 1 of 1 : SP\_2015\_NA0001\_55\_15\_20150317\_00015.jpg

LM Start	4.03	Rating **	U	Issue No.	15
LM End	4.03	Issue Type +	En	Location *	LS
Category	Earthen Levee			GPS Latitude/Longitude	
				Start	End
Item	Encroachments			38.585021 °	38.585021 °
				-121.445678 °	-121.445678 °
DWR ID	DWR_NA0001_04_s_2012_15				
Action/Comments					
Fence					
Inspector Comments: Privacy fence and evergreen shrub landscaping within 10-ft of the levee toe obstruct access and visibility.

03/16/2012 Wood privacy fence completely obstructs access and visibility.

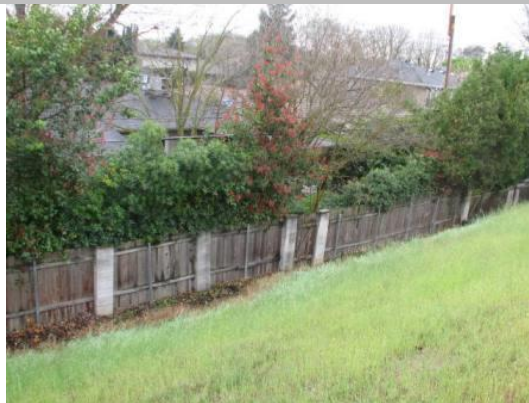
Photo 1 of 1 : SP\_2015\_NA0001\_55\_16\_20150317\_00016.jpg

LM Start	4.04	Rating **	U	Issue No.	16
LM End	4.04	Issue Type +	En	Location *	LS
Category	Earthen Levee			GPS Latitude/Longitude	
				Start	End
Item	Encroachments			38.584885 °	38.584885 °
				-121.445520 °	-121.445520 °
DWR ID	DWR_NA0001_04_s _ 2012_16				
Action/Comments					
Fence					
Inspector Comments: Privacy fence and landscaping within 10-ft of the levee toe obstruct access and visibility.

03/16/2012 Wood privacy fence completely obstructs access and visibility.

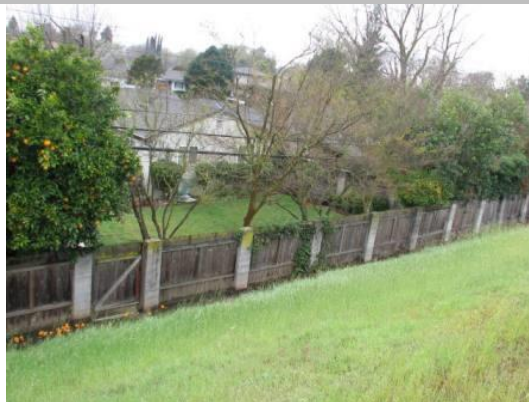
Photo 1 of 1 : SP\_2015\_NA0001\_55\_17\_20150317\_00017.jpg

LM Start	4.05	Rating **	U	Issue No.	17
LM End	4.05	Issue Type +	En	Location *	LS
Category	Earthen Levee			GPS Latitude/Longitude	
				Start	End
Item	Encroachments			38.584810 °	38.584810 °
				-121.445403 °	-121.445403 °
DWR ID	DWR_NA0001_04_s _ 2012_17				
Action/Comments					
Fence					
Inspector Comments: Privacy fence and maple tree landscaping within 10-ft of the levee toe obstruct access and visibility.

03/16/2012 Wood privacy fence completely obstructs access and visibility.

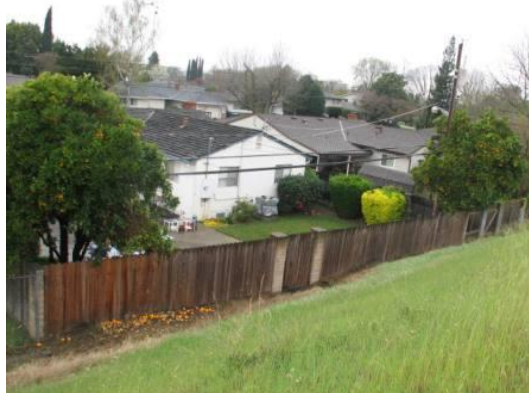
Photo 1 of 1 : SP\_2015\_NA0001\_55\_18\_20150317\_00018.jpg

LM Start	4.06	Rating **	U	Issue No.	18
LM End	4.06	Issue Type +	En	Location *	LS
Category	Earthen Levee			GPS Latitude/Longitude	
				Start	End
Item	Encroachments			38.584694 °	38.584694 °
				-121.445255 °	-121.445255 °
DWR ID	DWR_NA0001_04_s _ 2012_18				
Action/Comments					
Fence					
Inspector Comments: Wooden fence between orange trees is within 10-ft of the levee toe.

03/16/2012 Wood privacy fence completely obstructs access and visibility.

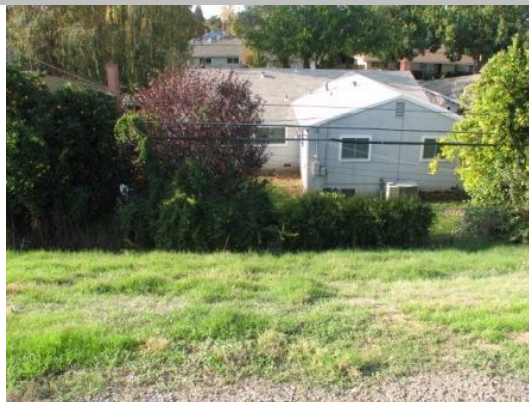
Photo 1 of 1 : SP\_2015\_NA0001\_55\_186\_20150317\_00162.jpg

LM Start	4.10	Rating **	M	Issue No.	186
LM End	4.10	Issue Type +	En	Location *	LS
Category	Earthen Levee			GPS Latitude/Longitude	
				Start	End
Item	Vegetation			38.584354 °	38.584354 °
				-121.444792 °	-121.444792 °
DWR ID	DWR_NA0001_04_s _ 2012_186				
Action/Comments					
Landscaping					
Inspector Comments: Landscaping on cyclone fence within 10-ft of levee toe obstructs access and visibility.

Fall 2009 photo: Landscaping within 10-ft of levee toe obstructs access and visibility.

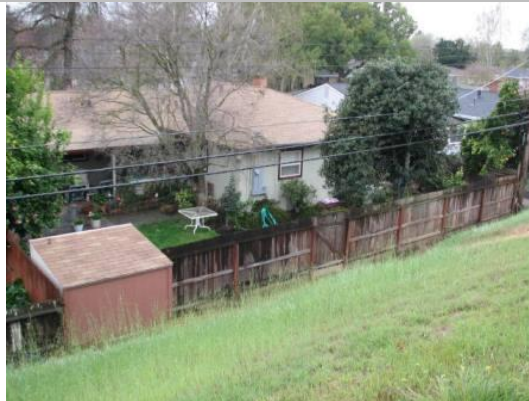
Photo 1 of 1 : SP\_2015\_NA0001\_55\_20\_20150317\_00020.jpg

LM Start	4.11	Rating **	U	Issue No.	20
LM End	4.11	Issue Type +	En	Location *	LS
Category	Earthen Levee			GPS Latitude/Longitude	
				Start	End
Item	Encroachments			38.584243 °	38.584243 °
				-121.444647 °	-121.444647 °
DWR ID	DWR_NA0001_04_s _ 2012_20				
Action/Comments					
Fence					
Inspector Comments: Privacy fence and shed within 10-ft of the levee toe obstruct access and visibility.

03/16/2012 Wood privacy fence completely obstructs access and visibility.

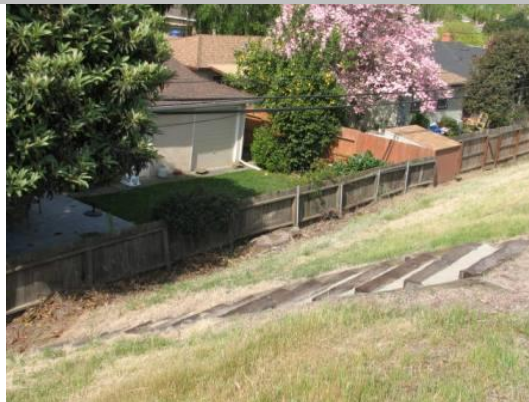
Photo 1 of 1 : SP\_2015\_NA0001\_55\_21\_20150317\_00021.jpg

LM Start	4.12	Rating **	U	Issue No.	21
LM End	4.12	Issue Type +	En	Location *	LS
Category	Earthen Levee			GPS Latitude/Longitude	
				Start	End
Item	Vegetation			38.584129 °	38.584129 °
				-121.444485 °	-121.444485 °
DWR ID	DWR_NA0001_04_s _ 2012_21				
Action/Comments					
Landscaping Inspector Comments: Palms and other landscaping on levee slope, as well as the wooden privacy fence within 10-ft of the levee toe obstruct access and visibility. 04/14/2011 Palms have been removed.

04/14/2011 Palms have been removed.

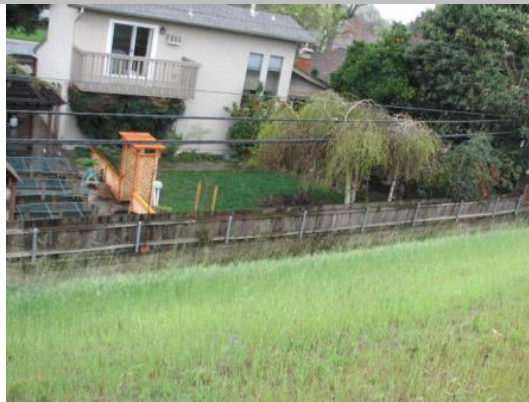
Photo 1 of 1 : SP\_2015\_NA0001\_55\_22\_20150317\_00022.jpg

LM Start	4.13	Rating **	U	Issue No.	22
LM End	4.13	Issue Type +	En	Location *	LS
Category	Earthen Levee			GPS Latitude/Longitude	
				Start	End
Item	Encroachments			38.584034 °	38.584034 °
				-121.444322 °	-121.444322 °
DWR ID	DWR_NA0001_04_s _ 2012_22				
Action/Comments					
Fence					
Inspector Comments: Cement block and wooden fence as well as the landscape planting are within 10-ft of the levee slope and obstruct access and visibility.

03/16/2012 Wood privacy fence completely obstructs access and visibility.

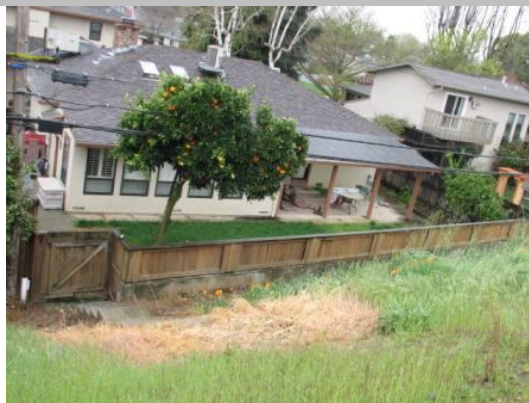
Photo 1 of 1 : SP\_2015\_NA0001\_55\_23\_20150317\_00023.jpg

LM Start	4.14	Rating **	U	Issue No.	23
LM End	4.14	Issue Type +	En	Location *	LS
Category	Earthen Levee			GPS Latitude/Longitude	
				Start	End
Item	Encroachments			38.583935 °	38.583935 °
				-121.444150 °	-121.444150 °
DWR ID	DWR_NA0001_04_s _ 2012_23				
Action/Comments					
Fence					
Inspector Comments: Cement block and wooden fence obstruct visibility.

03/16/2012 Wooden fence on cement wall obstructs access and visibility.

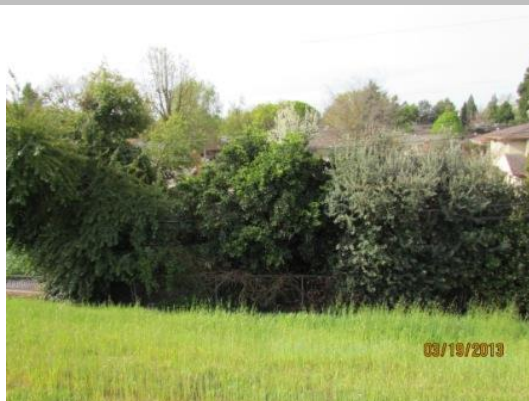
Photo 1 of 1 : SP\_2015\_NA0001\_55\_187\_20150317\_00163.jpg

LM Start	4.15	Rating **	M	Issue No.	187
LM End	4.15	Issue Type +	En	Location *	LS
Category	Earthen Levee			GPS Latitude/Longitude	
				Start	End
Item	Vegetation			38.583858 °	38.583858 °
				-121.443981 °	-121.443981 °
DWR ID	DWR_NA0001_04_s _ 2012_187				
Action/Comments					
Landscaping					
Inspector Comments: Orange, guava and other trees and landscaping obstruct access and visibility.

View of the obstructing vegetation at levee toe.

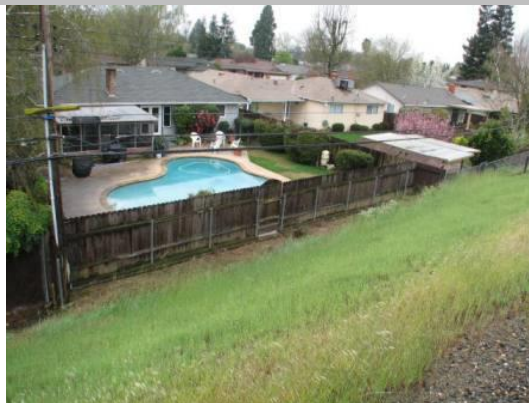
Photo 1 of 1 : SP\_2015\_NA0001\_55\_190\_20150317\_00164.jpg

LM Start	4.19	Rating **	U	Issue No.	190
LM End	4.19	Issue Type +	En	Location *	LS
Category	Earthen Levee			GPS Latitude/Longitude	
				Start	End
Item	Vegetation			38.583559 °	38.583559 °
				-121.443485 °	-121.443485 °
DWR ID	DWR_NA0001_04_s_2012_190				
Action/Comments					
Landscaping Inspector Comments: Planter boxes built into levee slope. Wooden fence obstructs visibility. Pool is just outside 10-ft from levee toe.

03/16/2012 Wood privacy fence completely obstructs access and visibility.
